Landslides on the escarpments of Western-highlands and flash floods in the Mbos plain (West-Cameroon)

Ediamam Epalle Guy Marcel

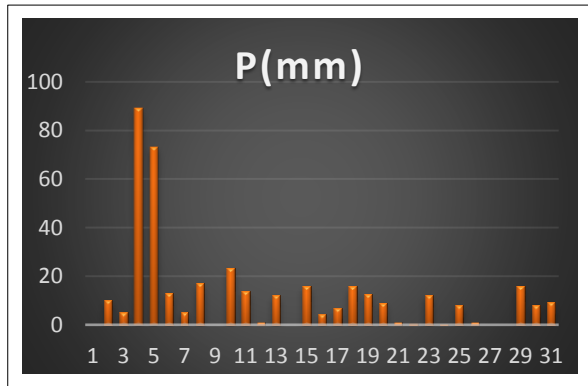
Figure5: Histogram of daily precipitation for the month of August 2017 in Santchou.

The rainfall is unevenly distributed throughout the month. However, there is an abnormal phenomenon, an exceptional precipitation. During two days, (4th and 5th), rainfall was 89.1mm and 73.2 mm respectively. In all, 162.3mm or 40.09% of the total monthly rainfall during the month of August in Santchou was concentrated in just the two days. Upstream, the consequences of this exceptional rainfall are: landslides, mudslides. Downstream, in the Mbos plain, catastrophic floods with 6 dead, numerous material damages and 257 displaced people were registered.

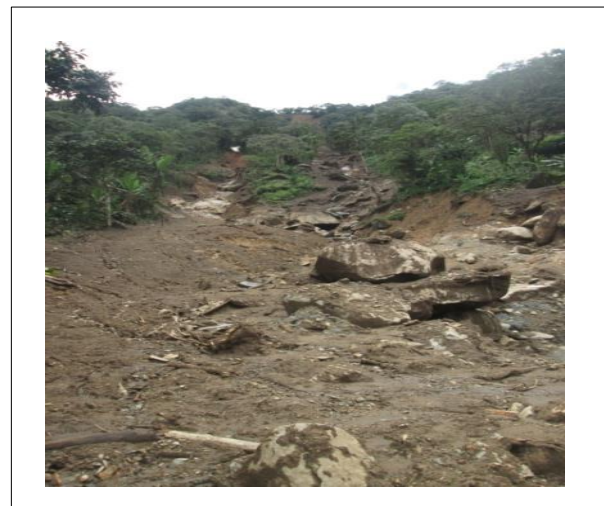
Photo 1: Landslides in Bebong

Photo1 shows the different phases of the landslide. The dropout niche **A** with the tearing of blocks of materials and earth, the transit zone **B** through which the cleared materials pass and the deposit zone **C** where there is an accumulation.

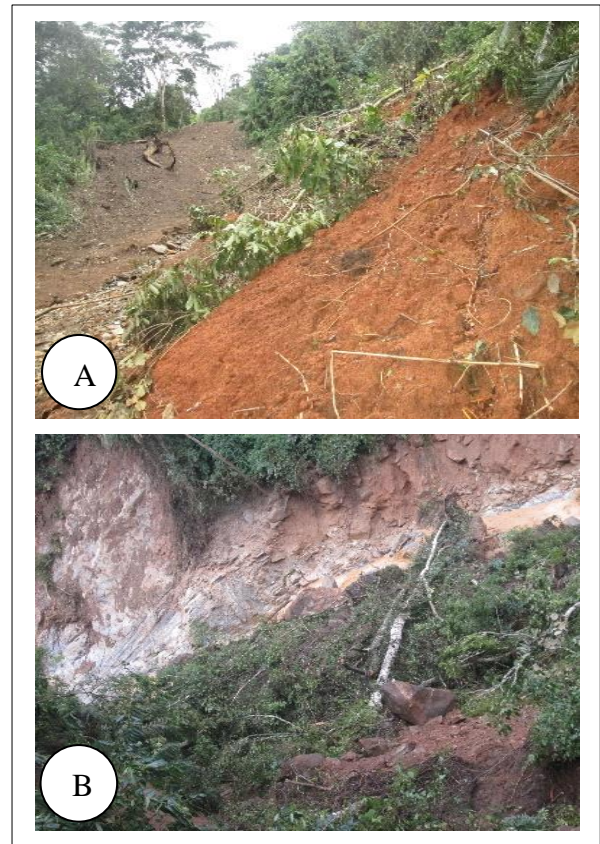
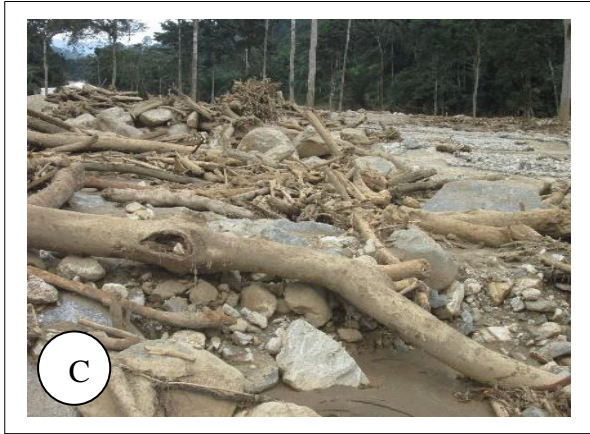
Plate 2: Flooding process from upstream to downstream

Plate 2 **A** shows the ablation niche with material tearing out. Plate 2 **B** shows the transit zone through which this material is transported; the average depth is 8m with a width of 3m to 5m on the slope. During transit, the material, often consisting of huge blocks of earth and trees, is torn off in the transit corridor. There is an increase in the load as the transport takes place. Plate 2 **C** shows the discharge area. The blocks of land and the tree trunks are unloaded at the entrance of the plain as the water loses its intensity due to the less and less vigorous slopes and the widening of the flow channel, the heaviest materials are abandoned. The soil is easily transported. The flow channel is 150 m wide.

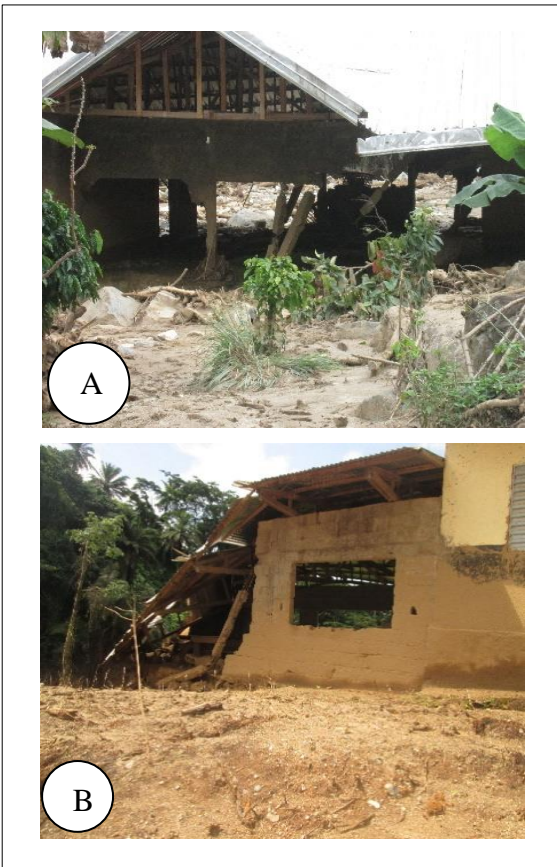
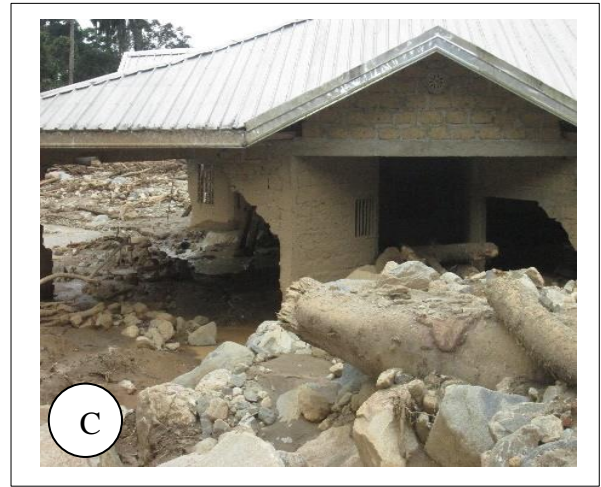
Plate3: Houses destroyed by the floods

Plate3 **A** shows a semi-clay house whose walls and pillars are completely destroyed and almost buried in gneiss from landslides upstream. They are deposited by the floods. This house built by a retired man was also used for pigsty (35pigs), goat (17), a chicken coop (155 chickens) which was destroyed by water. Plate3 **B** shows the partially destroyed public school in Bebong. This school is located on a slope. The water height is (1.5m) on the walls. Plate3 **C** shows a brick house completely destroyed by the floods.

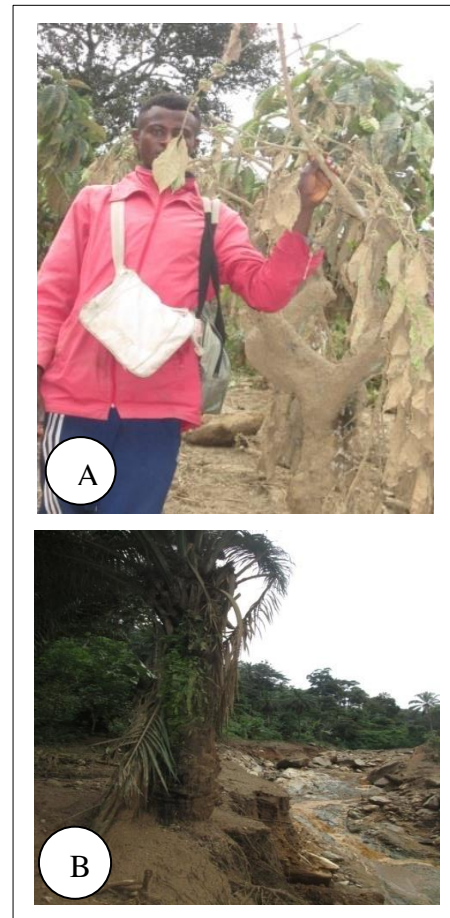
Plate4: level of water

The floods reached record heights over 8m upstream.

Plate4 **A** shows a gentleman (1.80m tall) standing at the foot of a coffee tree over 4m high from the thalweg. However, he does not measure up to the coffee tree which has been engulfed by water. On Plate4 **B**, we read the water height on the palm tree. Arrow indicates the level reached 3.5m from the banks. In reality, the total height is 8m.

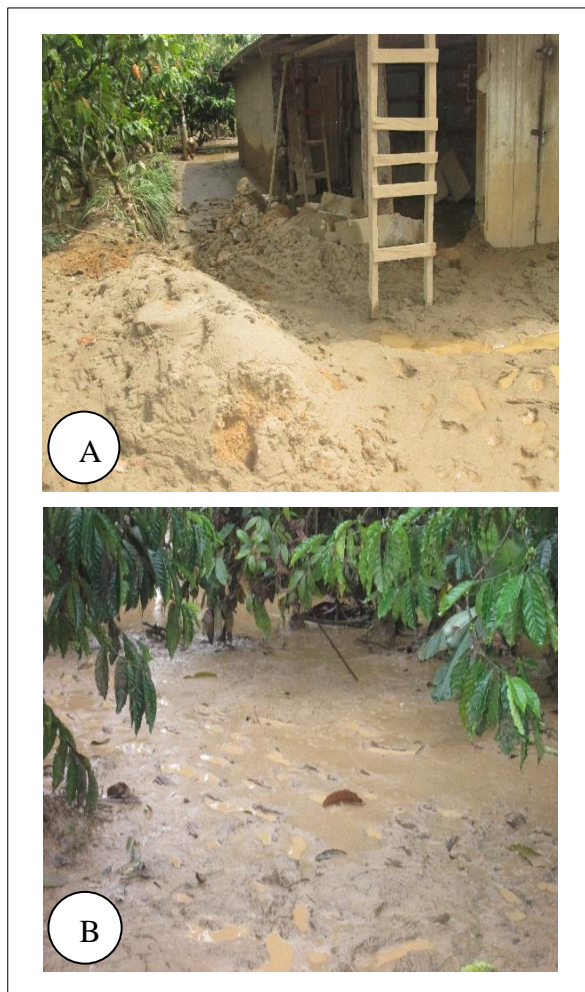
Plate 5: Depth of sludge

The thickness of the sludge varied according to the slope. Upstream, the average thickness is around 1.5m while downstream, due to the dispersion of water; it is 1m on average plate 5.

Plate5 **A** shows a house destroyed by floods at Echioc village. The thickness of the mud, around 1.5m, shows the extent of deposits of material torn upstream. Plate5 **B** shows a coffee farm trees completely covered with silt more than 1m thick.
